CHIMNEY SURVEY REPORT.

Site Location
CENTRAL LONDON

Title
**CHIMNEY SURVEY
16 / 17 PARTY WALL**

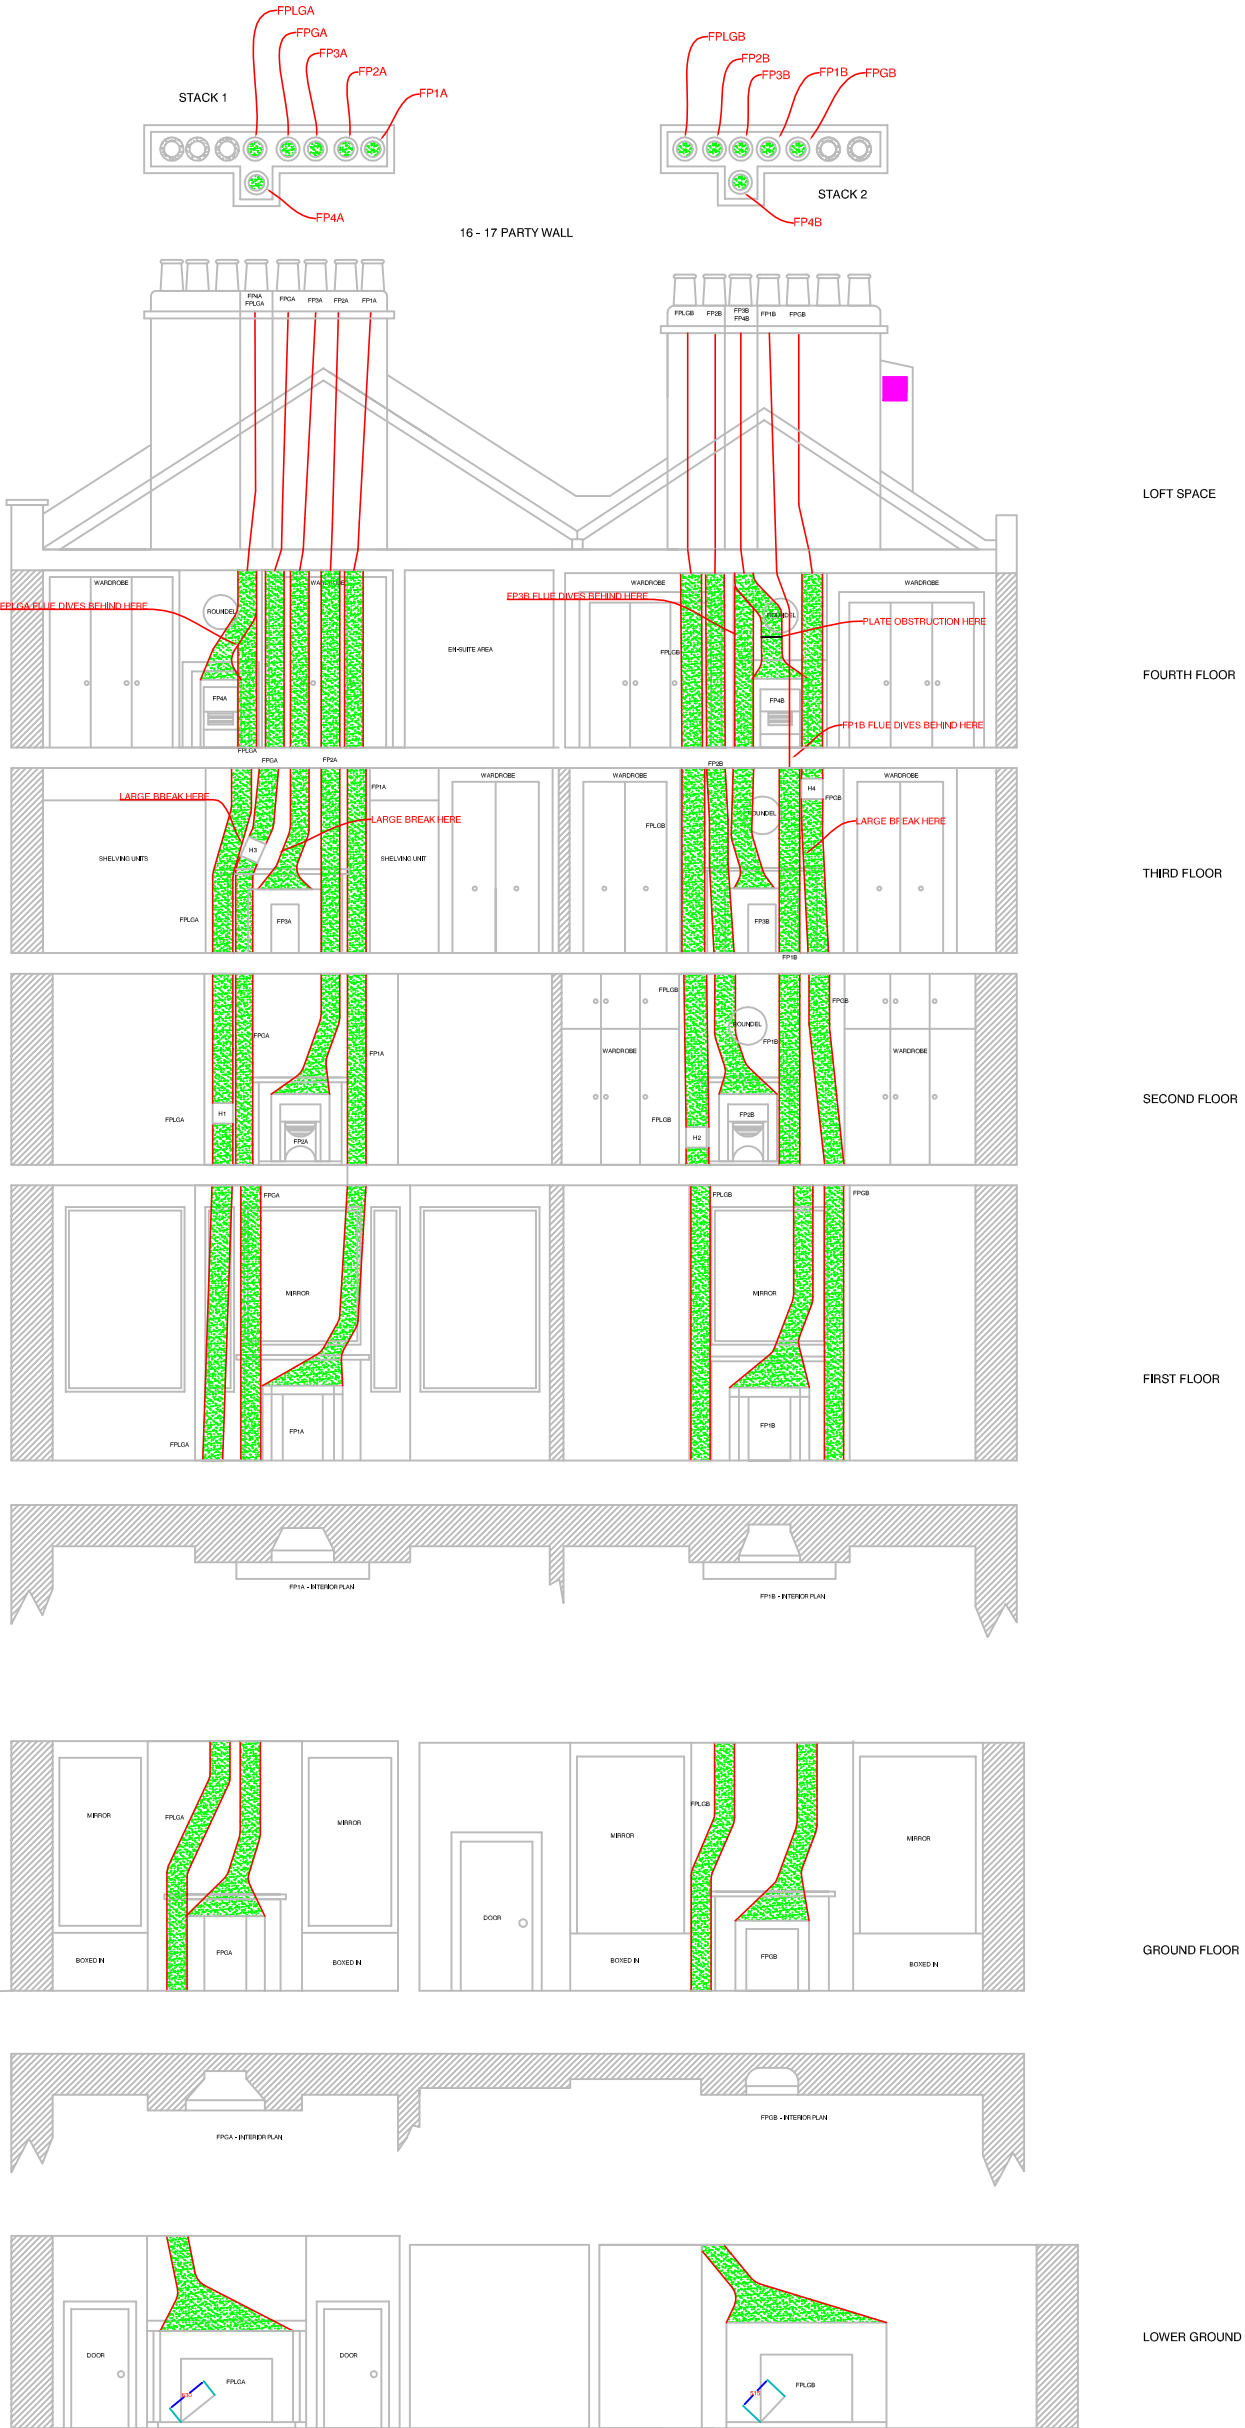
- KEY:**
- AIR VENT GRILLE:
 - BLOCKED-UP FIREPLACE:
 - OPEN EXISTING FIREPLACE OPENING:
 - UNLINED BRICK FLUE ROUTE:
 - BRICK FLUE CONTAINING SS GAS LINER:
 - BREAK-IN FOR ACCESS:
 - BREAK-IN TO CLEAR BLOCKAGE:
 - BLOCKAGE IN FLUE:
 - STEEL GIRDER:
 - CLAY CHIMNEY TERMINAL - (SIZE AND STYLE VARY):
 - METAL FLUE TERMINAL - (SIZE AND STYLE VARY):
 - PRESUMED FLUE ROUTE - (WHERE ACCESS IS NOT POSSIBLE):
 - FLUE ROUTE - (UNKNOWN ORIGIN):

- FLUE DIMENSIONS AT BREAK-INS:**
- H1 - FPLGA - 290mm W x 350mm D:
 - H2 - FPLGB - 330mm W x 350mm D:
 - H3 - FPGA - 270mm W x 350mm D:
 - H4 - FPGB - 310mm W x 420mm D:
- NB:**
ALL FLUES ARE ONE BRICK DEPTH UNLESS OTHERWISE STATED.

- NOTES**
- (a). No stack scaffold access was available at time of survey.
 - (b). Access to flues was gained via break-ins on upper floors - (only where necessary to avoid possible disturbance to neighbours or tenant).
 - (c). Flue routes were located and mapped using radio detection (RD) technology.
 - (d). Flues were prioritized in line with the client's request to locate flues to serve earmarked fireplaces for reinstatement and future use.
 - (e). All accessed flues were cleared of blockages where possible and swept using a power-sweep system.
 - (f). All accessed flues were CCTV surveyed internally.
 - (g). All information was collated analyzed and written-up in a report to accompany these drawings.
 - (h). Assessment and mapping of neighbouring chimney flues was not part of the scope as this would require sealing of neighbour's fireplaces and permissions by others.
